## Home Inspection Report

**John Sample**

1234 Any Street

Harder Certified Home Inspections

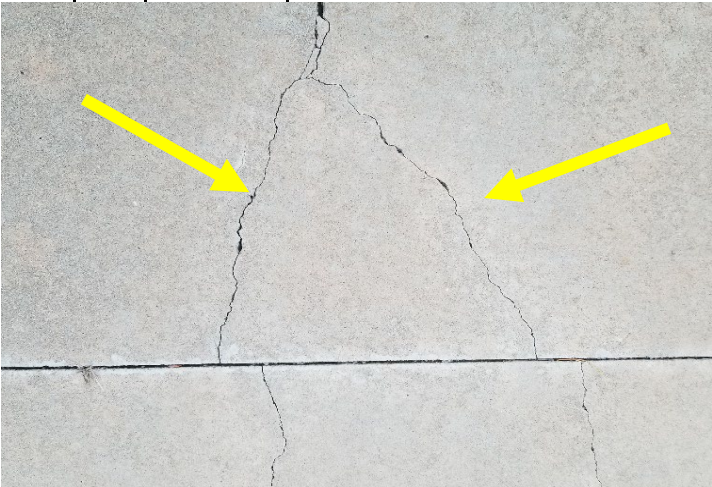
1

Driveway concrete cracks, normal.	M	✓
	R

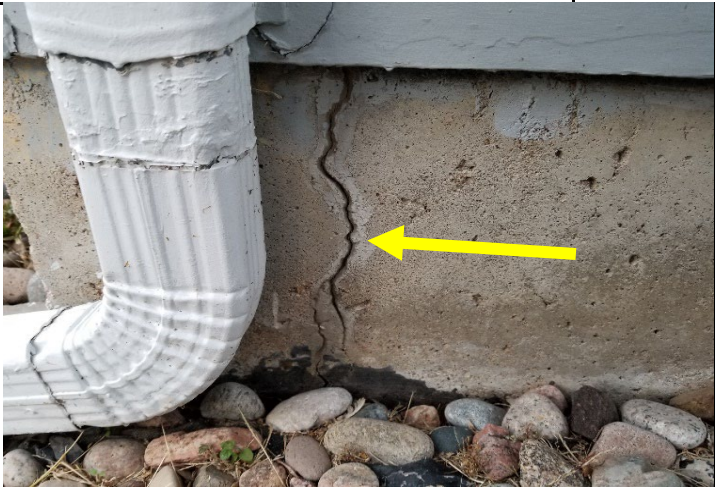
2

Foundation wall cracks around the outside foundation. Keep these cracks sealed.	M	✓
	R

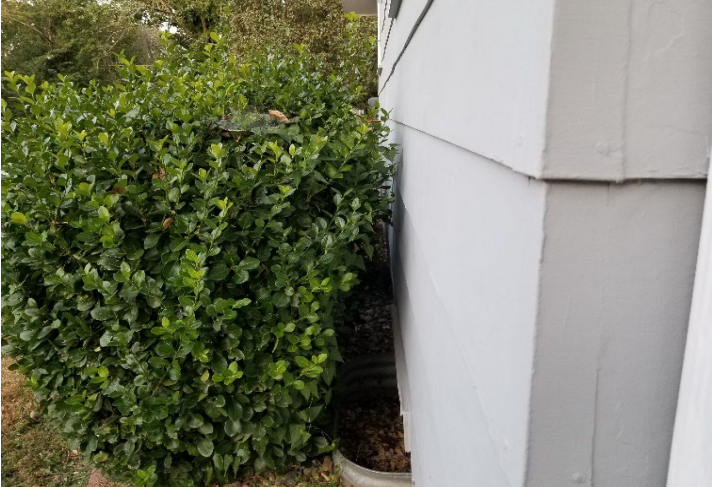
3

Keep all shrubs trimmed away from the house & foundation at least 1'.	M	✓
	R

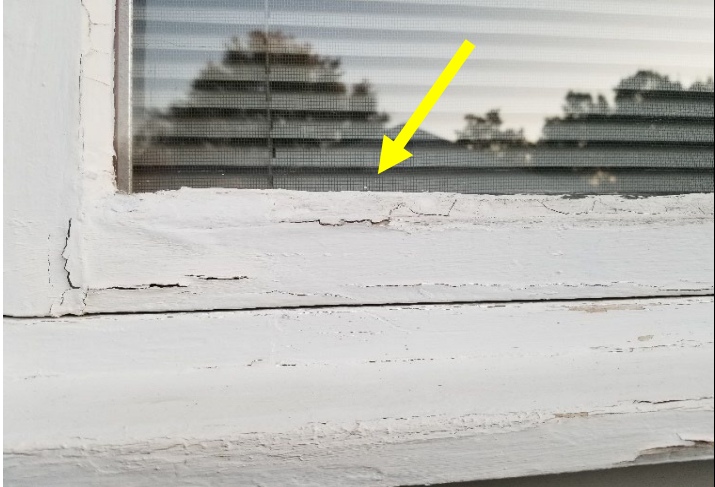
4

The exterior windows are wood & need to be kept well painted.	M	✓
	R

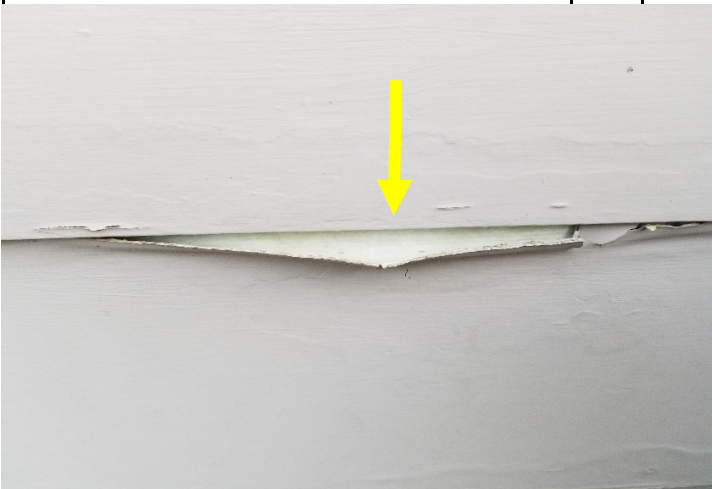
5

Several spots around the exterior the paint on the siding is peeling. Keep all siding well painted.	M	✓
	R

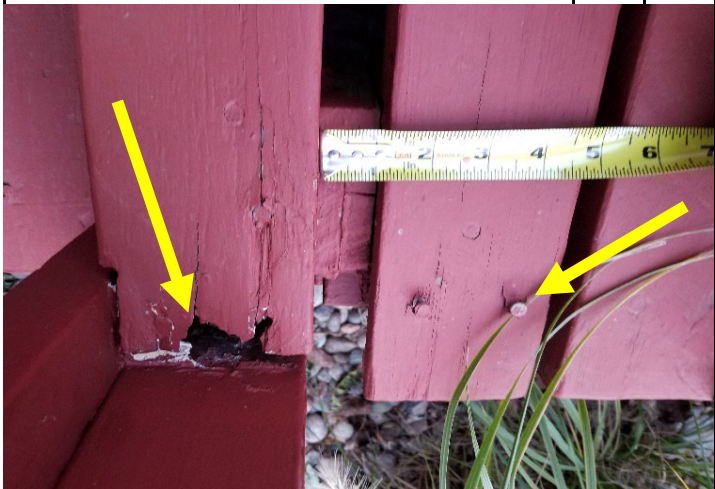
6

Spacing between deck boards should be no more than 1/8" to 1/4" between boards. This can be a tripping hazard. Also the end deck board is rotting & one of the deck boards have nails that need to be flush to the deck board.	M	
	R	✓

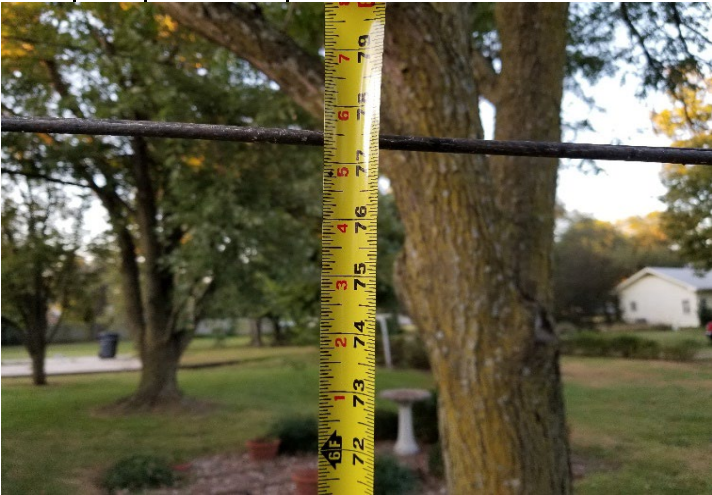
7

The cable TV wire in the back yard is very low to the ground & should be raised to at least 10' off of the ground.

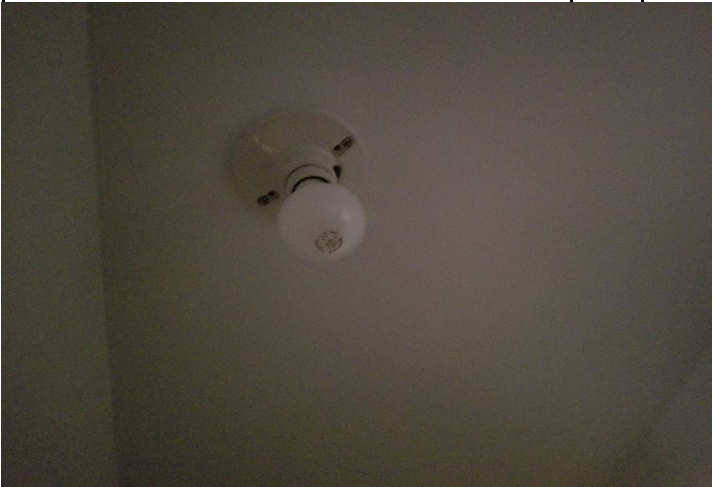
9

All bedrooms should have interconnected smoke alarms. All exposed light bulbs in closets should be in enclosed fixtures. Bedroom windows don't meet current egress requirements.

Closet lights should not have exposed light bulbs but should be in enclosed light fixtures.

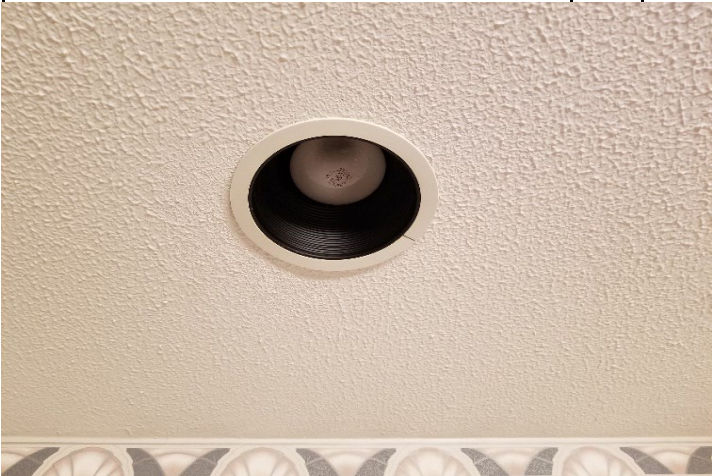
11

The can light over the hall bath tub/shower should have a moisture resistance lens cover.

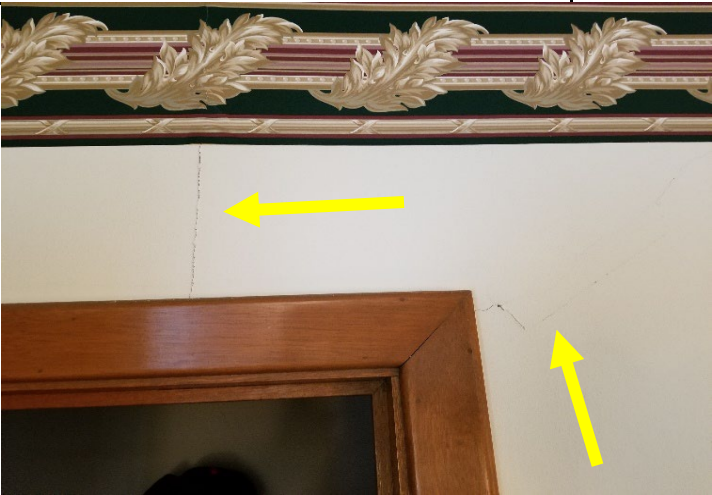
8

Sheetrock cracks around doors & windows in this age of house is very normal. These can be fixed very easily.

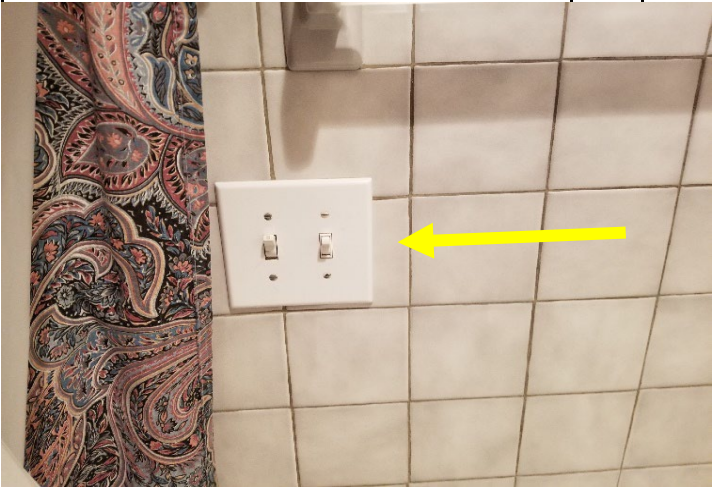
10

This electrical switch is inside of the tub/shower area. Consult with a licensed electrician about options.

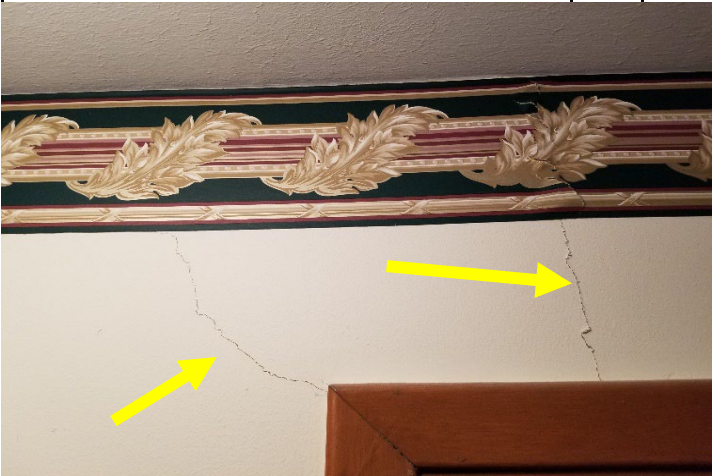
12

More sheetrock wall cracks above the hall bath door.

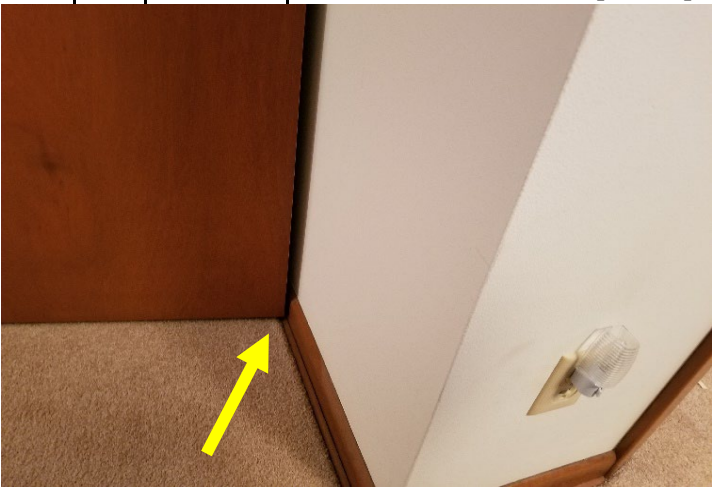
13

The corner back bedroom door hits the closet wall when open which keeps the door from opening all the way open.	M	✓
	R

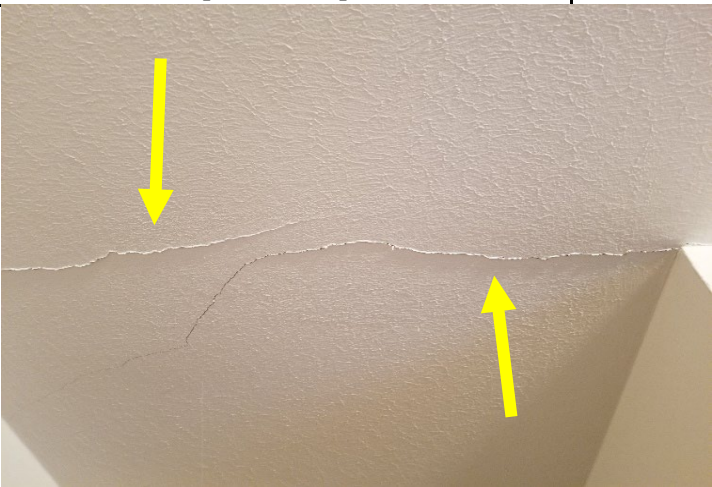
14

The back corner bedroom sheetrock ceiling is cracked. This is also normal for the age of the house.	M	✓
	R

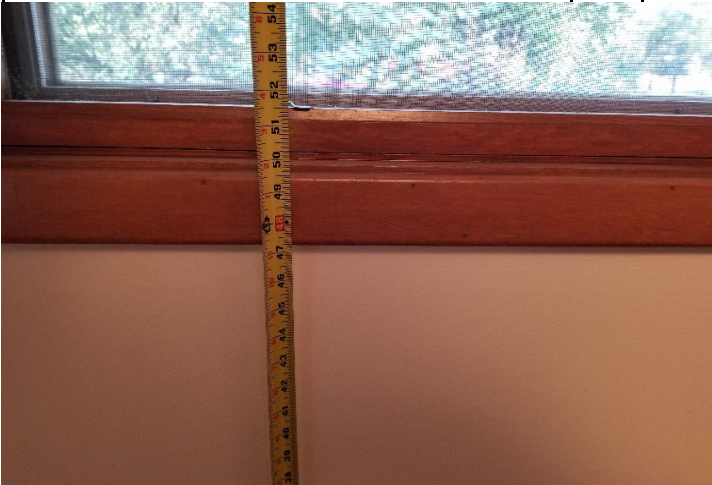
15

All of the bedroom windows don't meet egress requirements. Sill height should be no higher than 44". This house was constructed before these codes were enforced.	M	✓
	R

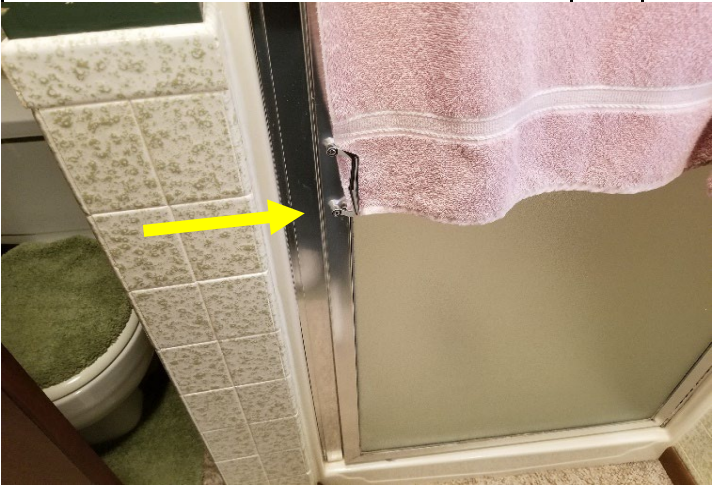
16

The utility room shower door doesn't close completely. It hits the metal frame in the middle, this can be adjusted.	M	✓
	R

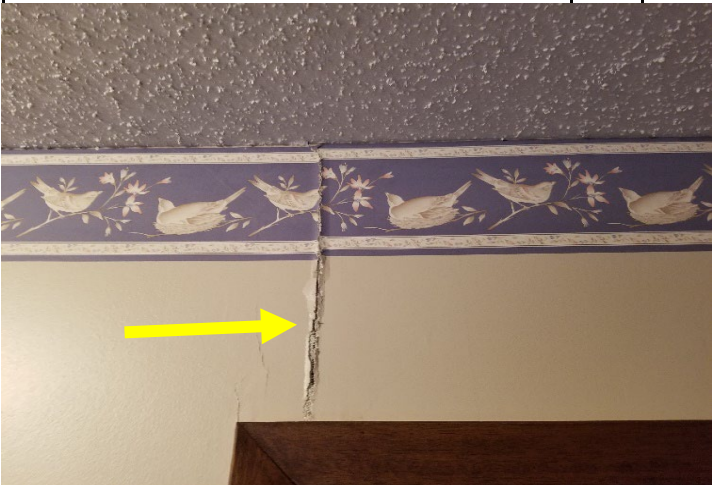
17

This sheetrock crack is inside the utility room over the pocket door. The pocket door opens hard when trying to get the door out of the wall.	M	✓
	R

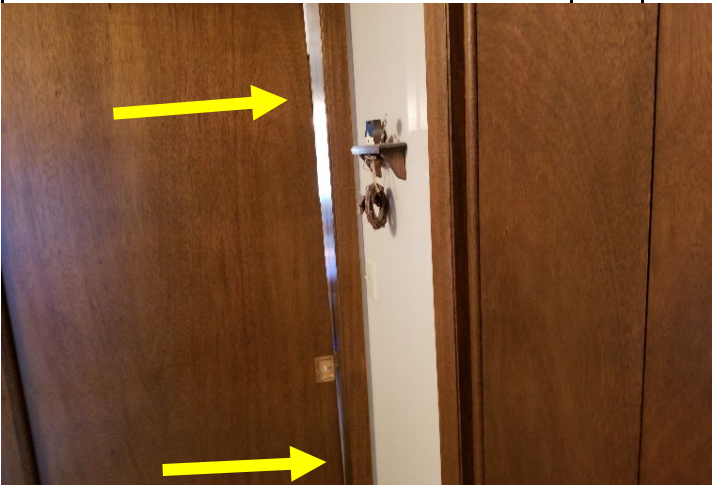
18

Utility room pocket door showing how the pocket door hits at the bottom of the frame & leaves a large gap at the top. This can be adjusted.	M	✓
	R

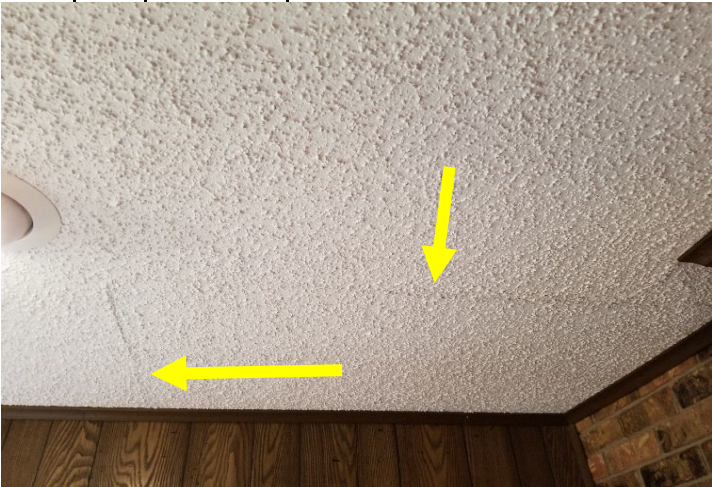
19

Family room ceiling northwest corner. Sheetrock crack or repair?	M	✓
	R

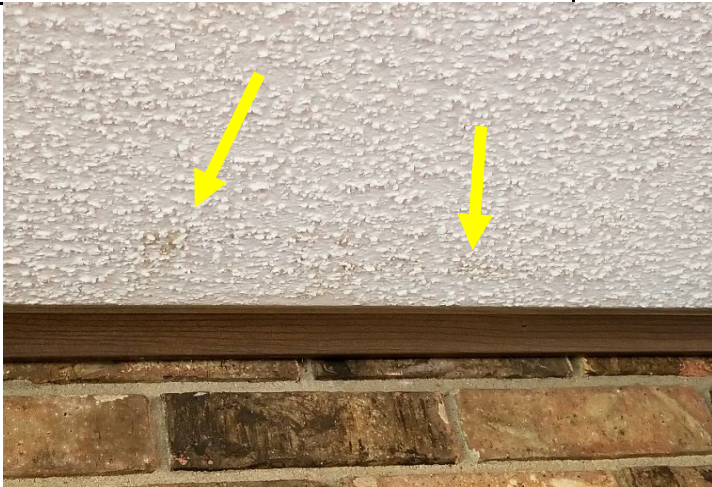
20

Over the family room fireplace it has signs that the roof did leak but new flashing has been installed around the fireplace.	M	✓
	R

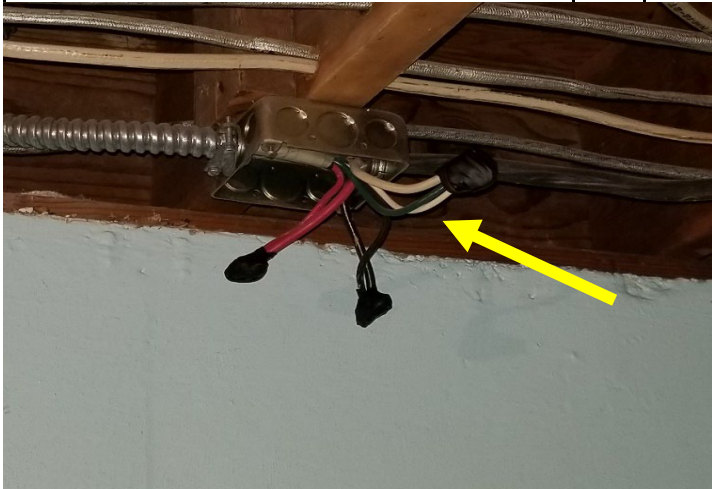
22

Northwest corner of the basement has a ceiling junction box that needs romex connectors on the wires & a cover plate.	M	
	R	✓

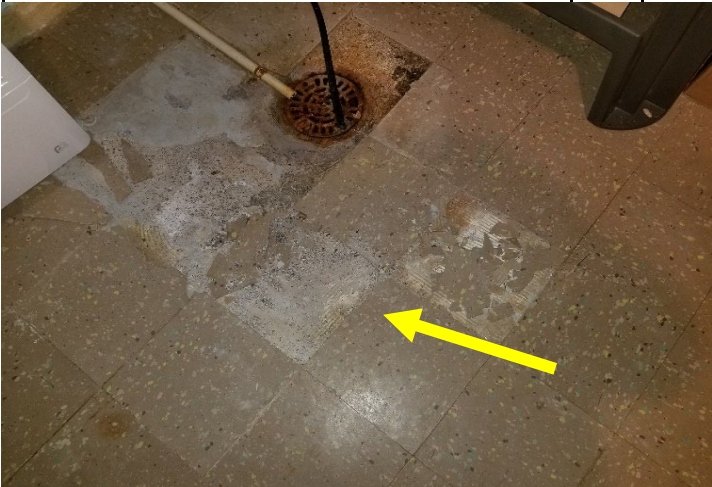
23

<i>Additional Comments:</i>	Generally, asbestos containing materials do not have to be removed from any residential property. In fact, asbestos containing material does not have to be removed from any residential structure unless it will be disturbed during renovations or demolition activities. As long as the asbestos containing material is in good condition, intact and will not be disturbed, it does not pose a significant health risk. The only time an issue should be made of asbestos is when it's exposed and friable, flaking or crumbling, and that it's likely to become airborne.
-----------------------------	--

See additional comments on page 7 about asbestos. Both the floor tiles & ceiling tiles in the basement could contain asbestos.	M	✓
	R

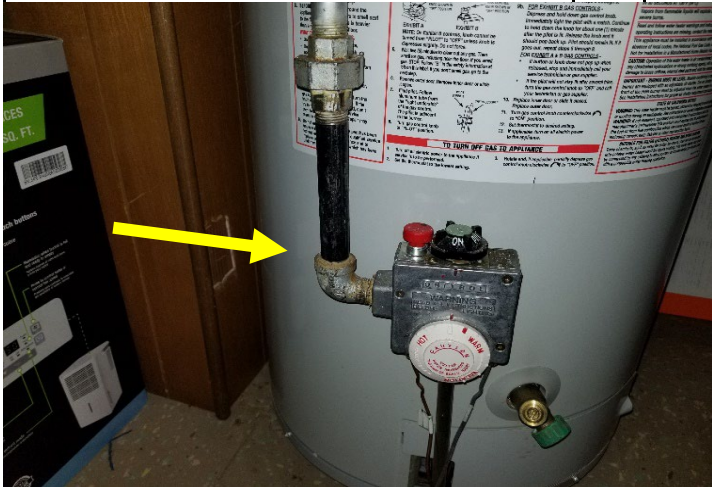
24

The water heater gas line lacks a sediment trap installed on the gas line. Consult with a licensed plumber.	M	
	R	✓

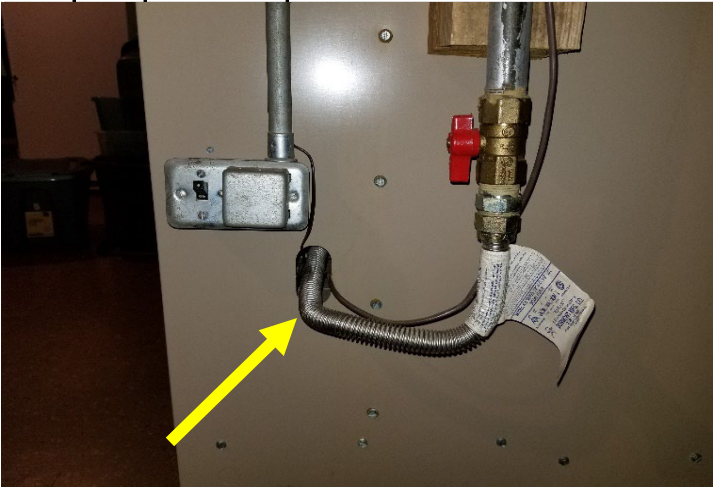
25

The furnace gas line also lacks a sediment trap before entering the furnace cabinet. Also the gas line entering the furnace should be hard gas pipe & not a flex gas line.	M	
	R	✓

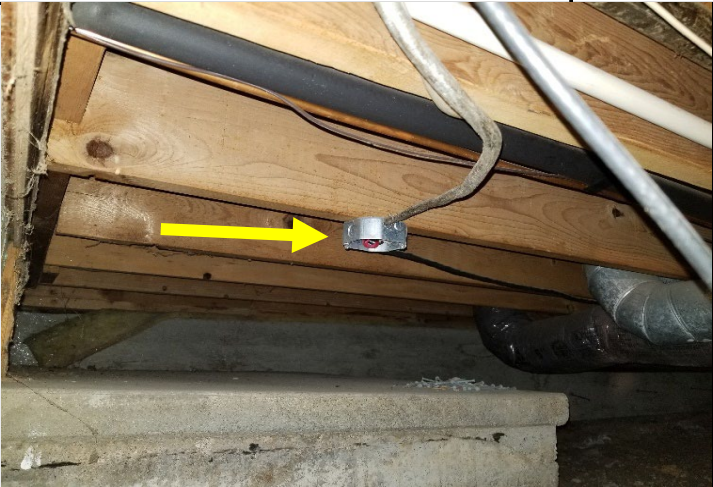
26

In the crawl space from the basement side an electrical junction box is missing a cover plate.	M	
	R	✓

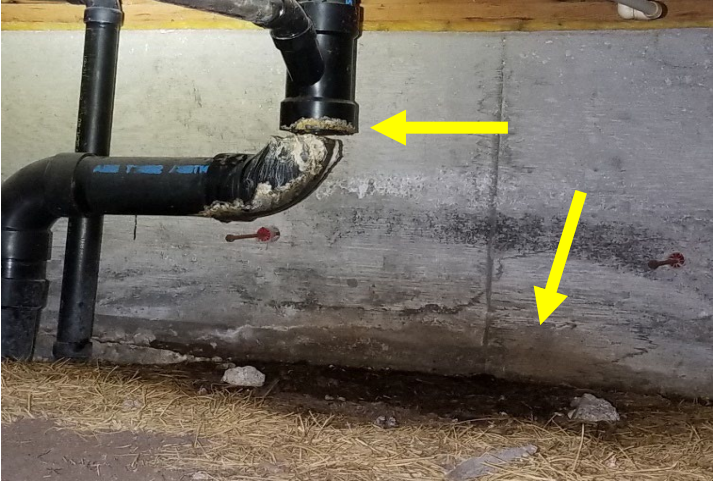
27

This is in the crawl space under the utility room bathroom. Looks like this ABS sewer pipe has been broken or not connected in a while. See page 6 comments under Plumbing System.	M	
	R	✓

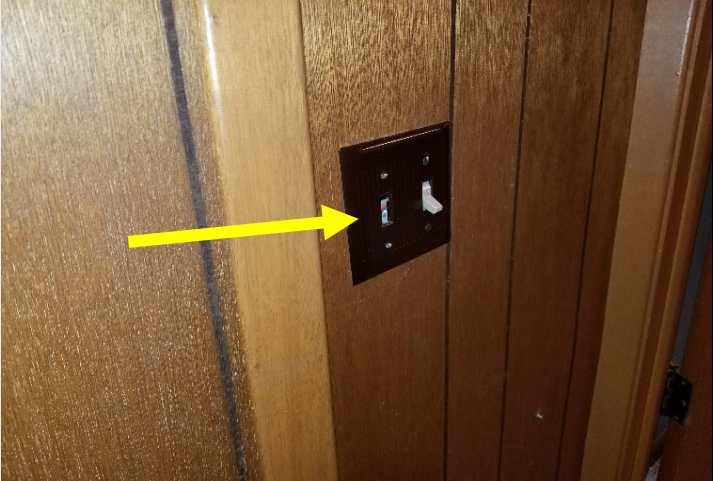
28

This stairway switch plate should have a filler plate added in the slot where a switch has been removed.	M	
	R	✓

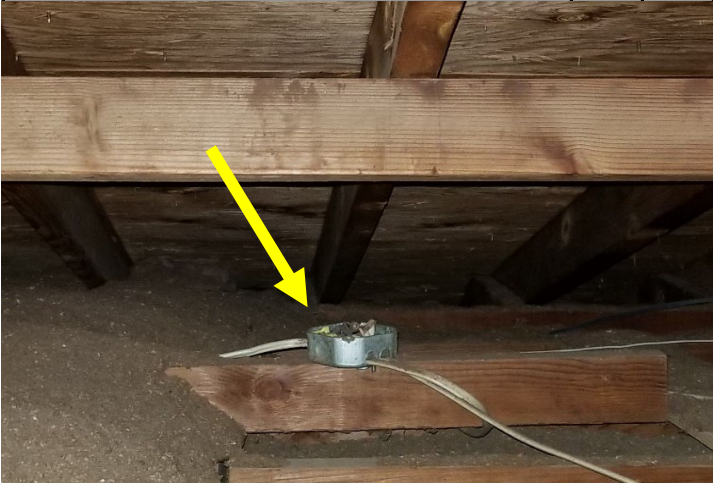
29

Electrical junction box in the attic over the garage needs a cover plate installed over the junction box.	M	
	R	✓

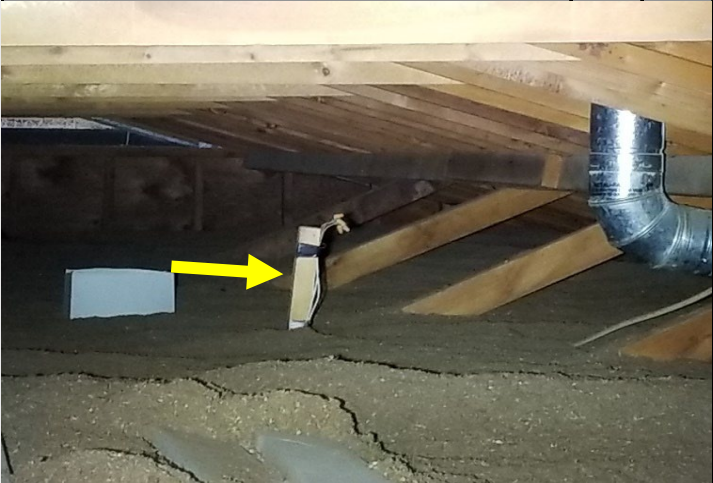
30

These look like wires that are connected with wire nuts. The wires look like they could be low voltage. If not they should be installed into a junction box.	M	✓
	R

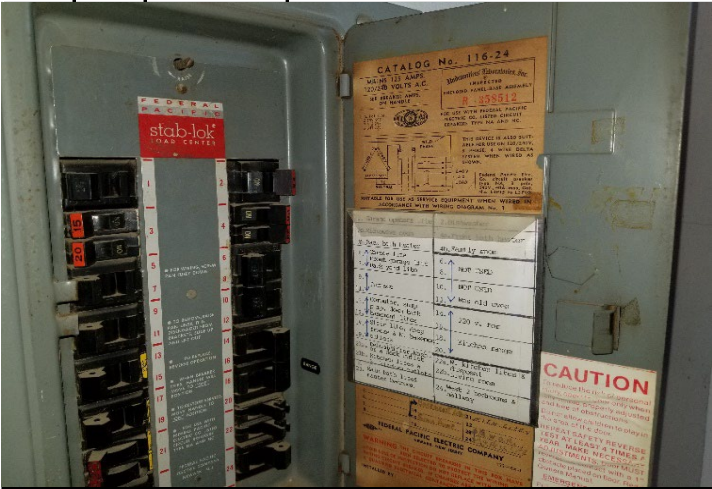
31

<i>Comments:</i>  Federal Pacific breaker panels. Multiple tests done on the breakers since the 1980s have proven that one in four Stab-Lok breakers are defective and will not properly trip off. Unfortunately, when the testing began in the early 1980s, a New Jersey court later ruled that Federal Pacific committed testing fraud and a cover-up, labeling the breakers as meeting the standards set by UL when in reality, they were defective. In 1983, the Consumer Product Safety Commission closed its two-year investigation and felt it impossible to create a product recall at the time because of budget issues, even as Federal Pacific panels and breakers continued to be installed in millions of homes that to this day still run the risk of an electrical fire. An estimated 2,800 fires each year directly result from Federal Pacific panel breaker malfunction. Federal Pacific Electric has been out of business for many years, but the danger and damage caused by their negligence continues.

The main breaker panel is a Federal Pacific breaker panel. See comments on the bottom of page 7 about Federal Pacific breaker panels.

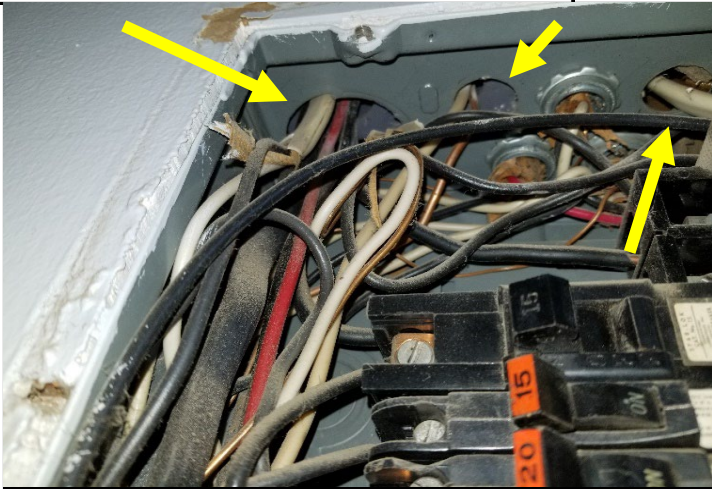
32

Breaker panel lacks NM or romex connectors on wires coming into the breaker panel both on the top & bottom.

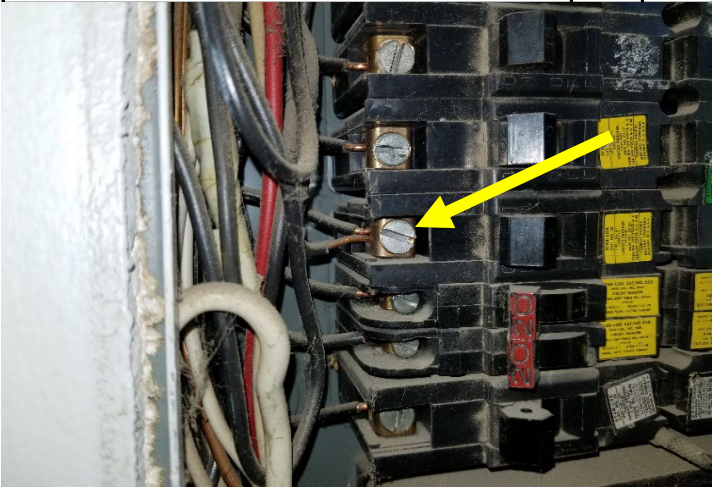
33

Double tapped breakers in the breaker panel. These breakers should only have 1 wire per breaker.

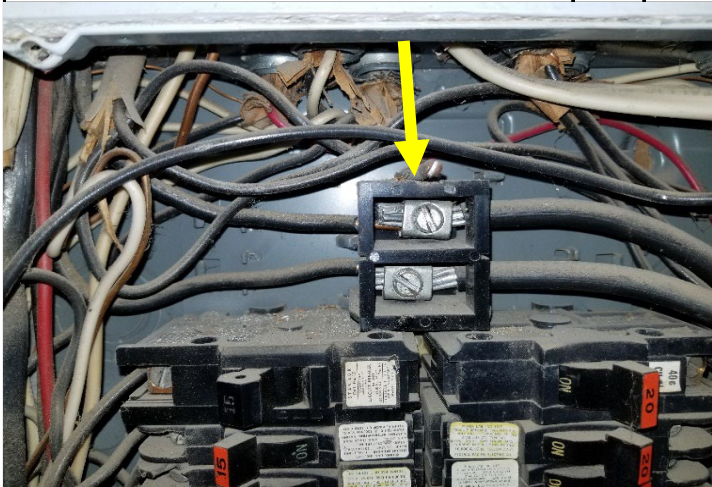
34

Main lugs in the breaker panel are double tapped. Also mixing aluminum & copper wires. Consult with a licensed electrician.

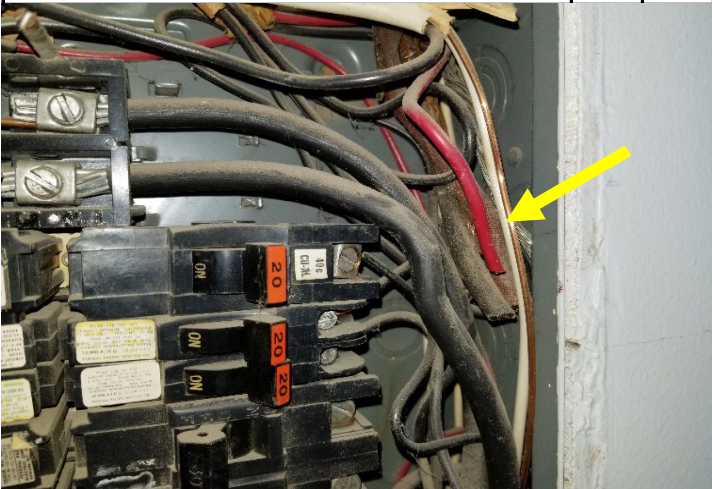
35

Breaker panel has loose wires that should have romex connectors installed on the wire ends.

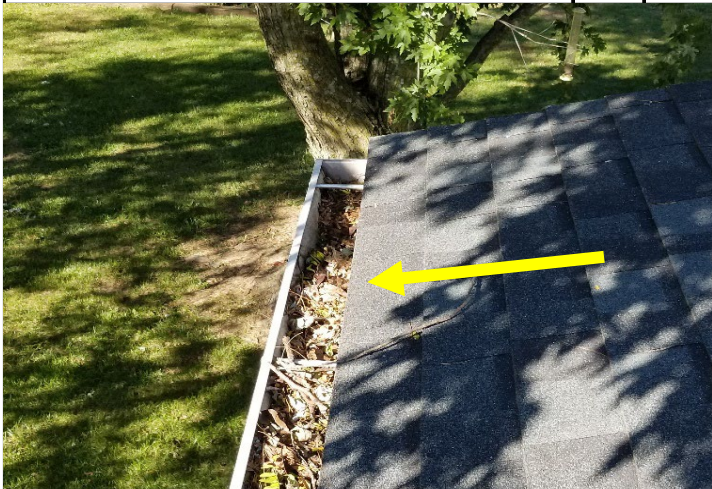
36

Gutters on the rear of the house are full of leaves & should be cleaned & kept clean.

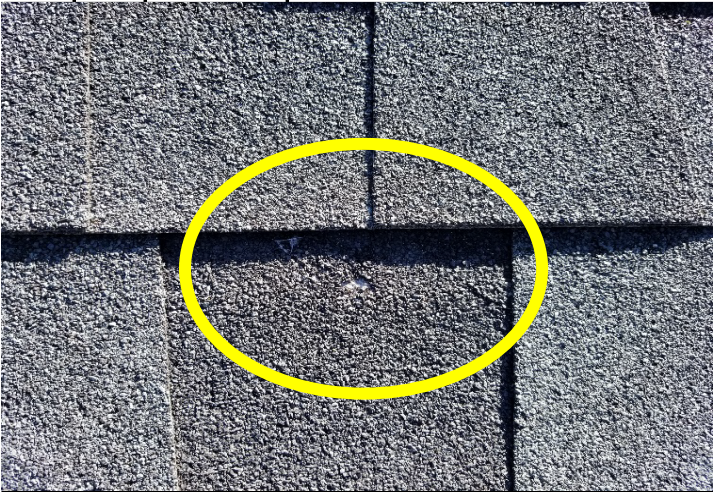
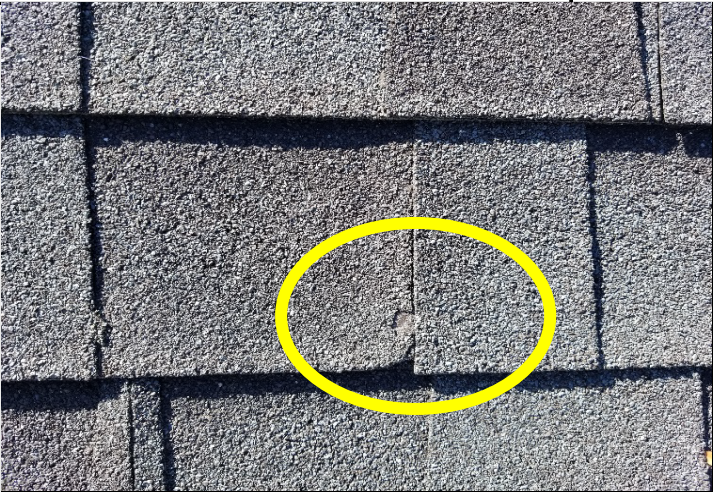
Pic #37 & 38 shows a couple of places on the roof that has what looks like hail damage. Not enough to need replacement of these shingles or roof.
