## Home Inspection Report

**John Sample**

1234 Any Street

Harder Certified Home Inspections

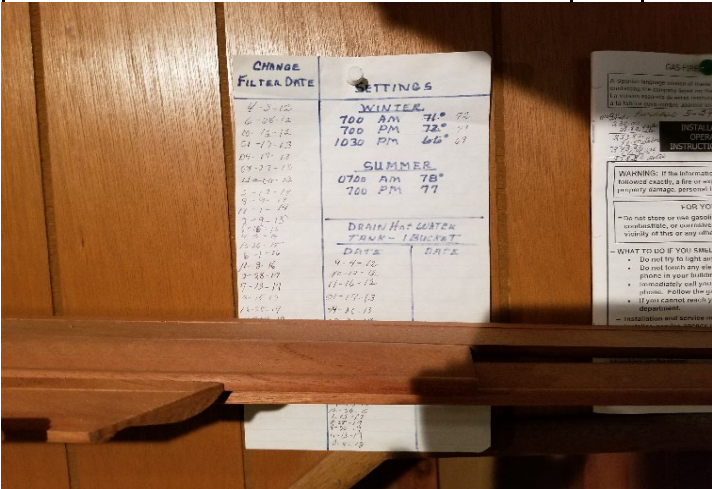
22

This paper hanging in the basement next to the water heater shows me how well these homeowners took care of their home. Very nice to see something like this.	M	✓
	R
